When is a quick fix the best answer?

An Ivy League university owned an apartment building used as a dormitory. They put in a new elevator, fire stairs, and replaced the roof. But leakage and widespread cracking remained in the stucco. Repairs had to be finished during a three-month window in the summer.

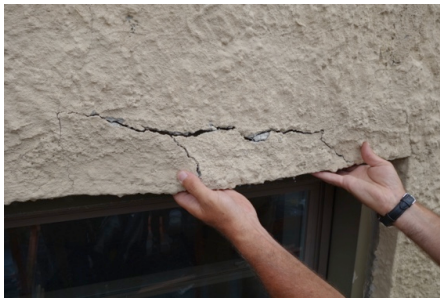
Stucco cracking was so bad that pieces fell out in our hands.

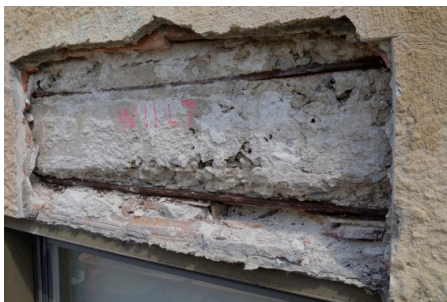
Deterioration concentrated at slab edges where rebar had rusted.

Rusting rebar was cracking the slab edge under the stucco

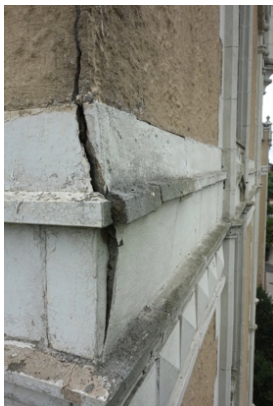
Terra cotta cracked and buckled outwards because rebar behind it severely rusted. The mortar had deteriorated to sand.
